Navajo Abandoned Uranium Mine

Site Screen Report

Horace Ben AUM Site

Navajo AUM Northern Region

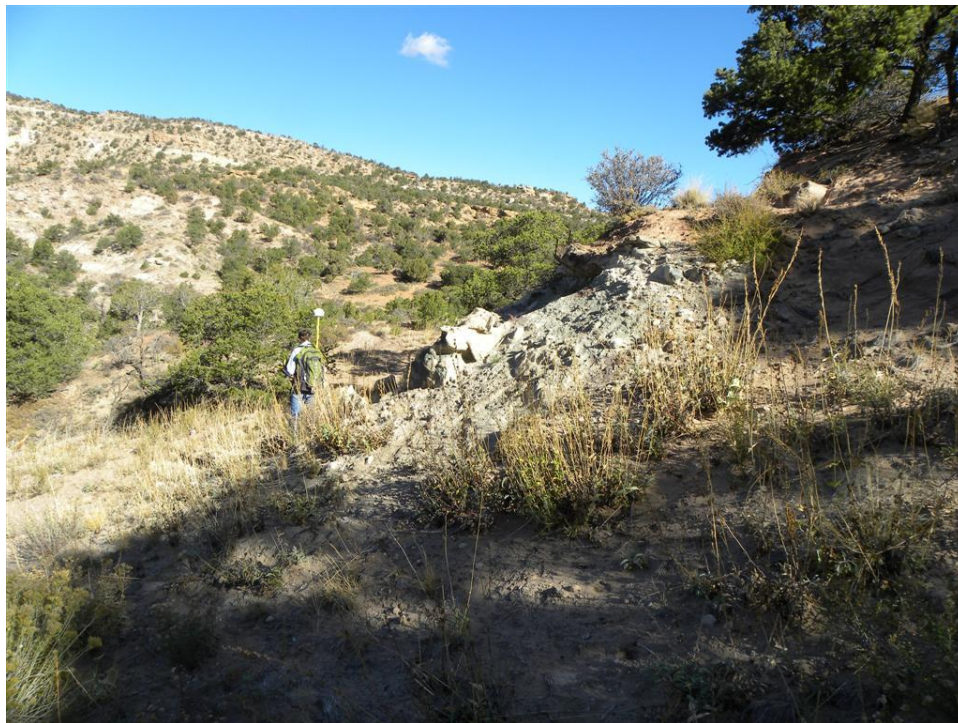
Waste rock debris down drainage wash 75' x 40', with a total estimated volume of 556 yd³

Photo 1. Waste rock

Unreclaimed waste pile

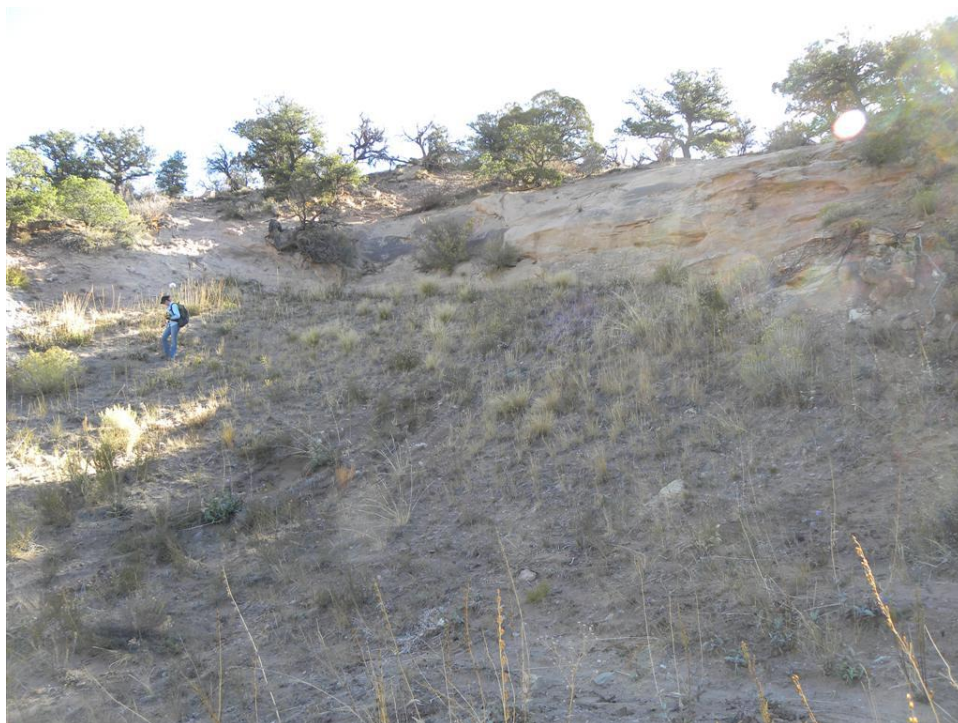
Photo 2. Down slope and waste rock

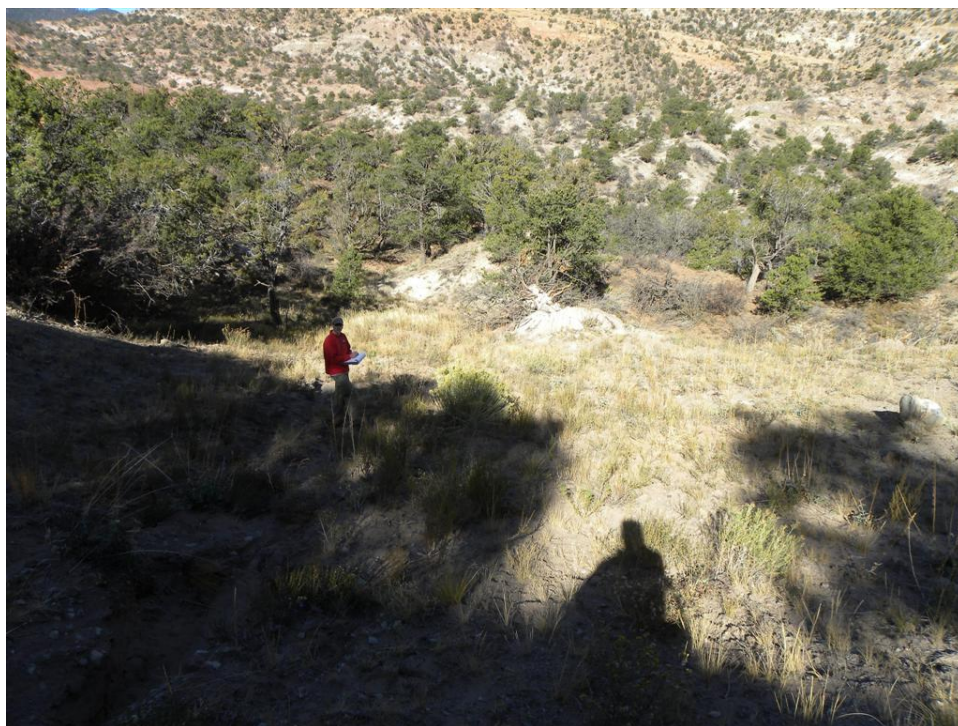
Photo 3. Down slope and waste rock
